Listed Buildings at Risk Survey 2015

**Buildings
identified as
At Risk**

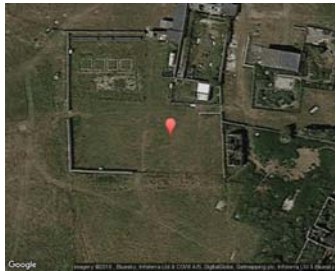
14094_1 - Laundry Building to former Isolation Hospital, Flat Holm

At Risk (1)

This building has not changed significantly since its previous inspection in 2006

Structurally unsound with multiple failures - loss may follow in short term

Major Repairs Required

Chimneys (render), Wall Pointing, Wall Render (smooth)

Full Replacement Required

Roof Covering (slate), Roof Flashings, Rooflights or Dormers (timber), Rain Water Goods (cast iron), Main Wall Structure (brick), Window Frames (timber), Window Glazing, Doors (timber)

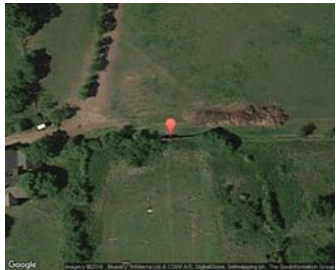
HAA Score - 21.42
 Condition is very poor, main structural elements serviceable but many items need

Major Repairs Required
 Main Wall Structure (brick), Wall Pointing

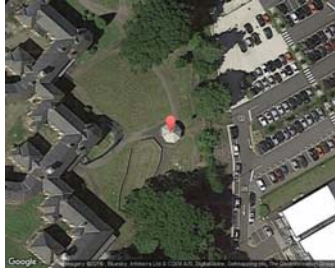
●●●●●●●● **HAA Score - 24.41**
Widespread replacement of defective items now needed, rapid action is required

- Minor Repairs Required**
- Main Wall Structure (timber frame)
- Major Repairs Required**
- Roof Covering (metal sheets), Window Frames (timber), Other Architectural Details
- Full Replacement Required**
- Window Glazing

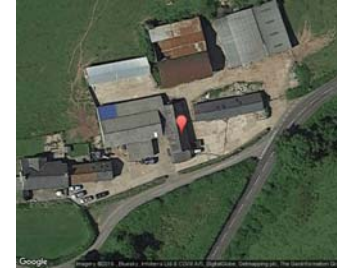
●●●●●●●● **HAA Score - 24.44**
Widespread replacement of defective items now needed, rapid action is required

- Minor Repairs Required**
- Main Wall Structure (stone), Wall Pointing
- Major Repairs Required**
- Roof Covering (slate), Roof Flashings, Rain Water Goods (metal), Doors (timber)
- Full Replacement Required**
- Window Frames (timber), Window Glazing

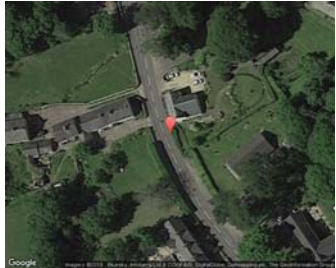
Speed of decay may be increasing, some items will now or soon need replacement

Main Wall Structure (stone)
